Manhole Inspection Summary

Manhole # S53I__022MH

Location Address: **400 highland**

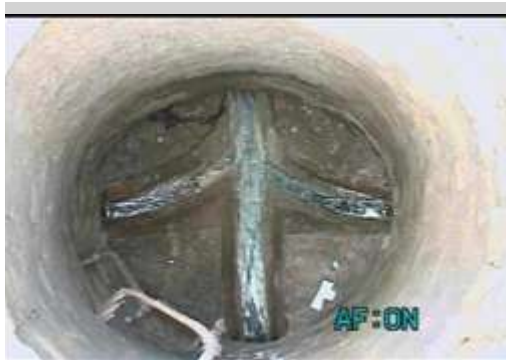
Defect 1

Count: **3** Missing: **0** ☒ **Corroded**

steps corroded

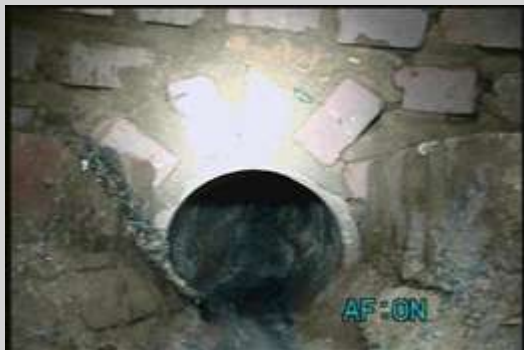
12 O'Clock Outflow

8 in. Circular Gravity Sewer
Pipe Out @ 12 O'Clock

Pipe Material: **Clay** ☐ Pipe Lined

Invert Depth: **8.30** (ft.) Flow Characteristics: **Fast**

Deposits: ☒ None ☐ Mud ☐ Sludge ☐ Debris ☐ Grease

Infiltration: **None** Pipe Seal Cond: **Unknown**

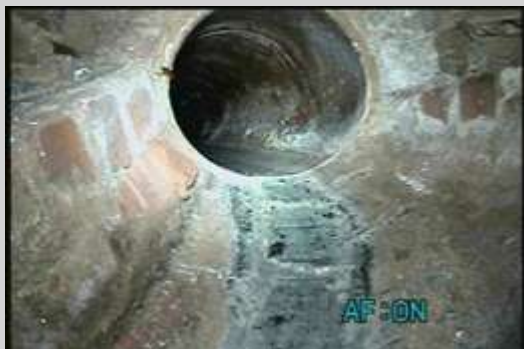
3 O'Clock Inflow

8 in. Circular Gravity Sewer
Pipe In @ 3 O'Clock

Pipe Material: **Clay** ☐ Pipe Lined

Invert Depth: **7.66** (ft.) Flow Characteristics: **Slow**

Deposits: ☒ None ☐ Mud ☐ Sludge ☐ Debris ☐ Grease

Infiltration: **None** Pipe Seal Cond: **Unknown**

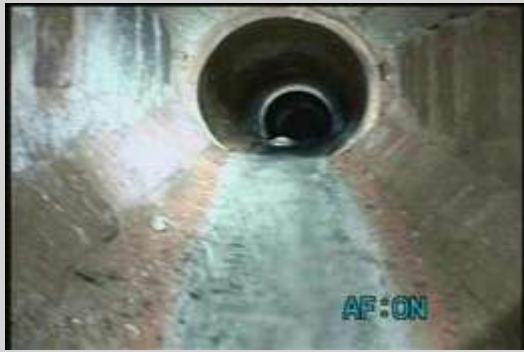
6 O'Clock Inflow

8 in. Circular Gravity Sewer

Pipe In @ 6 O'Clock

Pipe Material: **Clay** ☐ Pipe Lined

Invert Depth: **7.80** (ft.) Flow Characteristics: **Fast**

Deposits: ☒ None ☐ Mud ☐ Sludge ☐ Debris ☐ Grease

Infiltration: **None** Pipe Seal Cond: **Unknown**

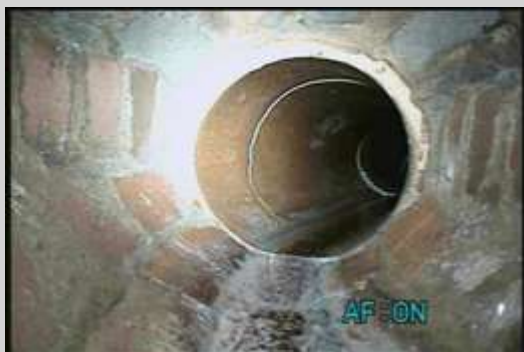
9 O'Clock Inflow

8 in. Circular Gravity Sewer

Pipe In @ 9 O'Clock

Pipe Material: **Clay** ☐ Pipe Lined

Invert Depth: **7.80** (ft.) Flow Characteristics: **Fast**

Deposits: ☒ None ☐ Mud ☐ Sludge ☐ Debris ☐ Grease

Infiltration: **None** Pipe Seal Cond: **Unknown**
